# Cost Analysis of Soot Blower Use for Boiler Maintenance at Sasol Secunda

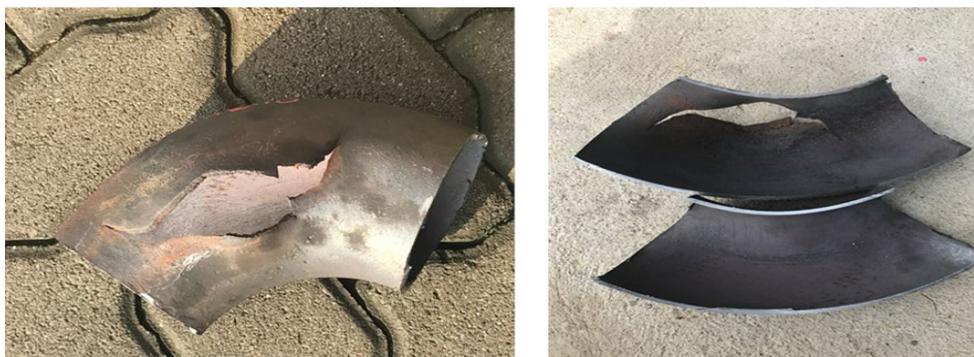
Apart from General Overhaul (GO), the company also experiences numerous breakdowns during operation which often means short-term outages, from time to time which in turn minimizes availability of the boiler and loss of production. Figures 2 and 3 shows the failure on soot blower elbow which ruptured during operation and was sent to the metallurgy department for analysis and finding were obtained in a form a report. The report stated that on the 21st of March 2018, a rupture of an elbow from the 043BO-501 ring feed header was noted. It was subsequently cut and replaced. It was reported that the location of the rupture on the elbow was at the 6 O'clock position. The

Figure 2: Thick-lip Rupture on the Neutral Axis of the Elbow of a Soot Blower [3].

Based on the findings of the failure investigation, it is believed that the final rupture was due to a pressure excursion in the line. The rupture occurred at the area where corrosion fatigue cracks were believed to have already

manifested. Evidence of that corrosion fatigue cracks had already manifested at the rupture area includes the pits and fissures. The presence of corrosion fatigue cracks and a pressure excursion made the propagation of the existing cracks into a large rupture very easy. Evidence of that the rupture was caused by a pressure excursion is that the propagation direction of the crack changed from the neutral axis to an angle  $45^\circ$  from the neutral axis [5].

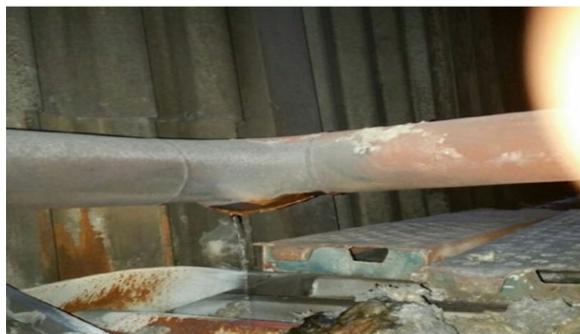
Figure 3: One of the Failures on the Soot Blower Elbow on [3].

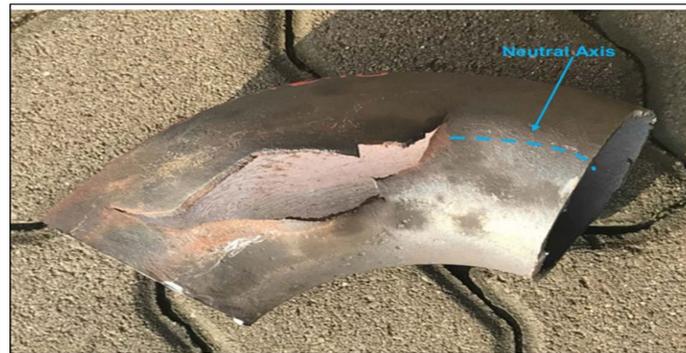
A visual examination of the submitted elbow was carried out in order to document the as-received condition of the sample. A summary of the findings of the visual examination are given. Figure 4 is a photograph of the elbow sample. It was noted that there was a rupture on one side of the elbow, the rupture occurred mainly along the neutral axis of the elbow. The external surface of the elbow appeared to have no other significant damage. After the visual examination of the external surface of the elbow sample, it was longitudinally sectioned for the internal surface to be examined. A photograph of the sectioned sample is given in Figure 5 [3].

Figure 4: A failed elbow from the ring feeder header [3].

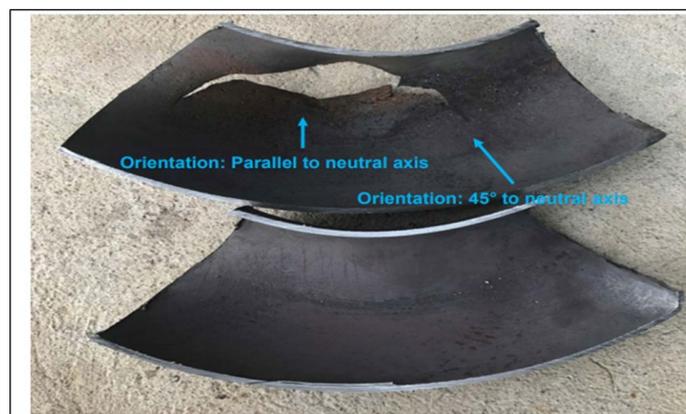
Figure 5: A photograph of the sectioned sample [3].

The internal surface had a black appearance which can be attributed to the formation of magnetite on the internal surface. It was noted that the significant damage was located mainly on one half of the sample - the bottom lying in the 6 o' clock position. It was noted that the orientation of the rupture was mainly longitudinal and along the neutral axis, however, the tips of the rupture are orientated 45° from the neutral axis. Given in Figure 6 is a photograph of the internal surface of the elbow section where most of the damage was located. Pitting and fissures along the neutral axis were noted as well.

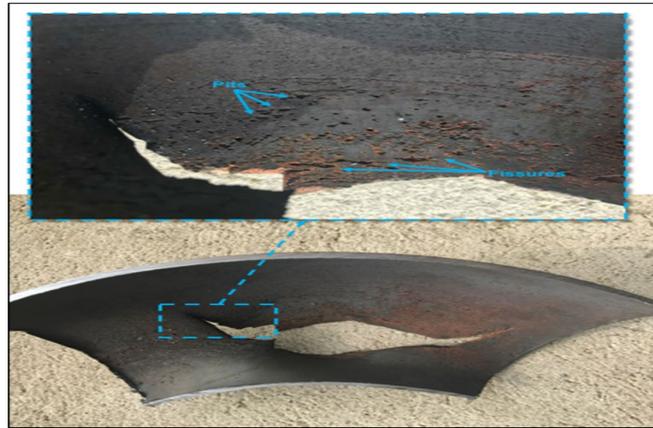
Figure 6: An internal surface of the elbow section with most damage [3].

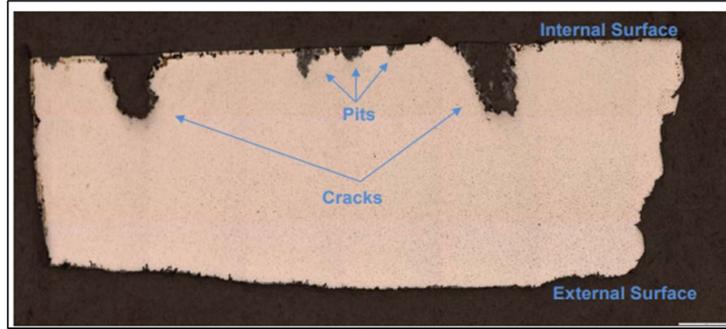
A sample for metallographic examination was sectioned from the damaged half of the elbow. The sectioned sample was prepared using standard metallographic techniques and was subsequently etched with Nital to reveal the microstructure. The etched sample was then examined under the light optical microscope. A photomicrograph of the pipe section where pits and fissure cracks were noted is given in Figure 7. It was noted that the cracks were almost parallel to each other and propagated perpendicularly to the inner surface. Evidence of superficial corrosion and pitting corrosion was noted on the internal surface. A higher magnification photomicrograph of the fissure crack is shown in Figure 8. It was noted that the crack was unbranched, oxide filled and had a blunt tip. A photomicrograph of the general microstructure of the elbow section is given Figure 9. The microstructure that was observed was that of a typical carbon steel. A microstructure of pearlite colonies in a ferrite matrix was noted. No evidence of thermal degradation of the microstructure was noted, despite installation of an incorrect material according to the drawing [3, 6].

Figure 7: A photomicrograph of the cross-section through the pits and fissure cracks.

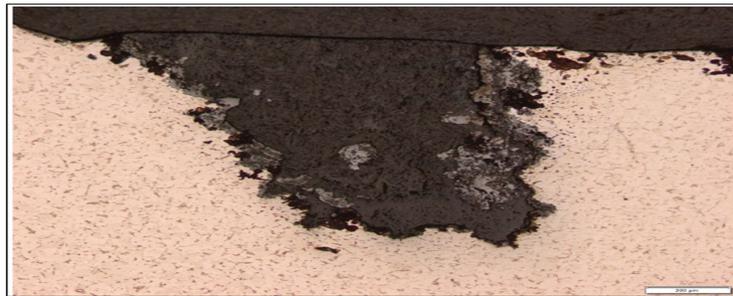
Figure 8: A higher magnification of one of the fissure cracks.

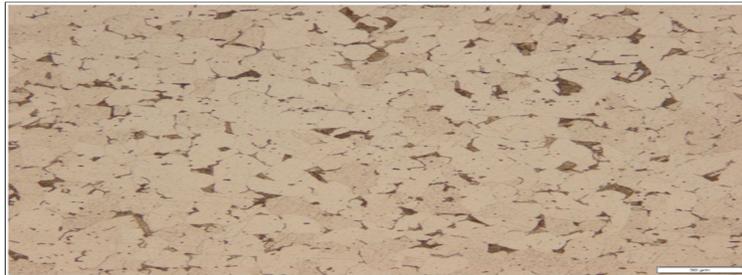
Figure 9: A photomicrograph of the general microstructure of the elbow.
