# Review of Engineer Professionalism in Construction Project Failure: A Case Toll Road Project in Indonesia

**Keywords:** Construction Failure, Deterioration, Pier-head, Toll road.

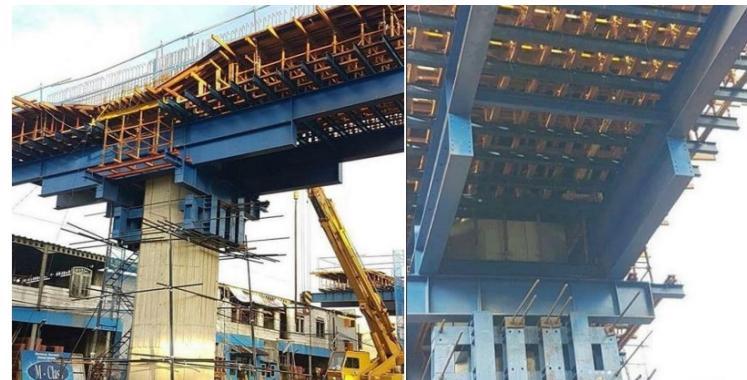
Figure 1. Cantilever system formwork on the pier-head of the Becakayu Toll Road

The pier-head of the Becakayu Toll Road Construction Project is reinforced concrete cast in place. Implementation of casting in place (in situ) requires formwork. Implementing the formwork (supporting) for the pier-head used is the cantilever system formwork/bracket system.

The key to the strength of the bracket/cantilever system formwork in bearing the load is the bracket in the form of tie-rod iron, which is embedded in the pier structure's body. The loads in question are fixed loads (own weight of formwork and cast material), variable loads (equipment, workers, etc.).

4. Re-analyze the strength of the pier-head formwork  
The pier-head formwork used in the Becakayu Toll Road Project is a cantilever/bracket system. The load on the formwork is entirely transferred to the pier body through the brackets. To reduce stress on the bracket, it can be done by installing reinforcing scaffolding/shoring. Shoring is a component made of metal assembled into a modular unit, which is usually used to strengthen freshly cast concrete (compressive strength is not optimal). In the case of the Becakayu Toll Road pier head, the shoring system can be used to carry the burden during and after casting. This reduces the stress on each bracket connected to the pier head body.

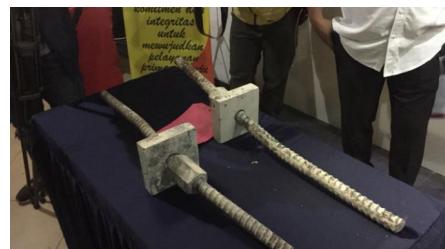
Figure 2. Thread-bar on the pier-head formwork bracket for the Becakayu Toll Road Project

Material deterioration is a deterioration in the quality of a material. In the Becakayu Project, indications of material deterioration are on the bracket and thread bar, made of steel. The use of formwork at the pier head of the Becakayu Toll Road uses a system, namely the type of formwork that can be reused due to the typical structural dimensions so that there is an indication that the steel material is experiencing fatigue. In examining the accident's cause, eight

thread-bars, as shown in Figure 2, are used as evidence, which is considered healthy. The material is then tested regarding the material's existing condition (tensile strength, deformation value, and so on). It is also planned that the material will be simulated with the same load when the failure of the formwork occurs. In essence, the strength of steel material is its tensile strength.

In connection with the deterioration of steel material in the Becakayu Toll Road Project, the effect of plastic steel material directly impacts the bracket's ability to withstand loads when casting. Repeated use of brackets without any supervision/checking before each use can increase the risk of brackets and thread bars that are approaching increasingly high plastic properties.

2. Improved material supervision  
Material control can be improved by conducting periodic checklists with a series of tests. The material contained in the pier head bracket formwork is steel material. Tests commonly carried out on steel materials include tensile strength, deformation, and corrosion tests. The effect of corrosion on steel materials can reduce the strength of steel materials.
