Ergonomic Design of NLEX Toll Booth in the Philippines

Jenalyn Shigella G. Yandug and Marvin L. Cruz
School of Industrial Engineering and Engineering Management
Mapua University
Muralla St., Intramuros, Manila
jsgyandug@mapua.edu.ph, mlcruz@mapua.edu.ph

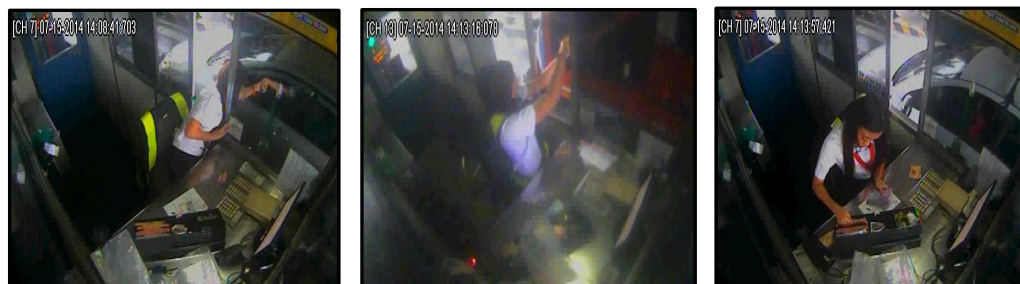
Figure 1. Current Working Posture of Operators

The researchers also evaluated the current working posture of toll booth operators using the Rapid Upper Limb Assessment (RULA). Based on the analysis, the operators are exposed to high level of work-related upper limb disorders due to the current design of toll booth facility. The RULA result shows a score of 7 for both toll transaction of the subjects handling class-1 and class 2 & 3 vehicles. This indicated that the design of the toll booth particularly the workstation used needed to be investigated and changed immediately. The result is shown in the figures below.

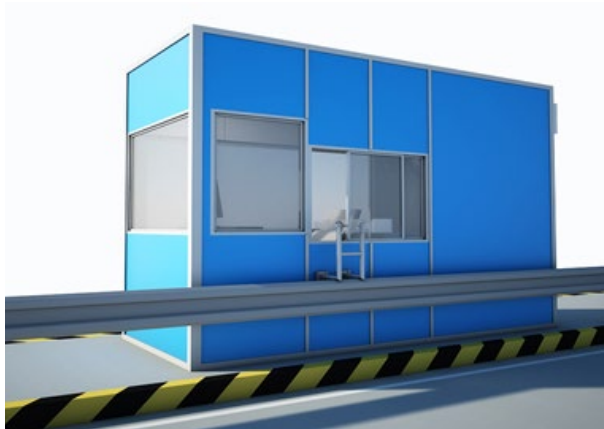
Figure 2. Perspective View of Toll Booth for Class 1 Vehicle Lane

There are two toll booth design the researcher had been proposed. One is for the class-1 toll booth lane where money slide equipment must be installed outside. The Next design is for the class 2 & 3 toll booth lane where money drop equipment must be installed outside. The images presented below are the perspective and top views of proposed ergonomically designed toll booth made via AutoCAD software.
